STM32W108xx Errata sheet

STM32W108xx device limitations

This errata sheet applies to the STMicroelectronics STM32W108xx microcontroller family.

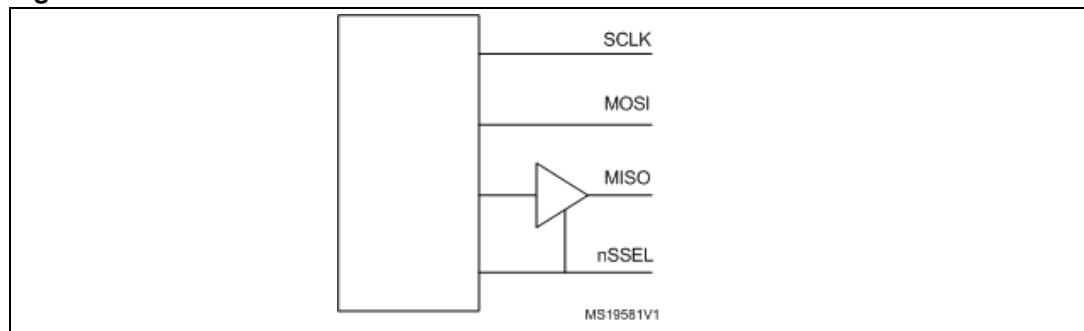
Figure 1. External MISO buffer

There is an issue in the serial controllers of the chip which prevents it from being used on a SPI bus that is shared with other SPI slave peripherals. The MISO (Master-In /Slave-Out) output from the chip does not tri-state when nSSEL (Slave Select) is deasserted.

This causes contention on the shared MISO signal with other peripherals when they are selected via their own nSSEL inputs. The MISO output will continue to be driven either high or low, depending on the state of the last bit that was transmitted prior to nSSEL deasserting.

As shown in [Figure 1](#), an external buffer may be added to the MISO output with its enable connected to nSSEL. This buffer will allow the MISO signal presented to the SPI bus to be tri-stated, and will allow other SPI slave peripherals to share the same bus.
