Thank you for designing with the Xilinx Virtex®-6 family of devices. Although Xilinx has made every effort to ensure the highest possible quality, the devices listed in [Table 1](#) are subject to the limitations described in the following errata.

## Devices

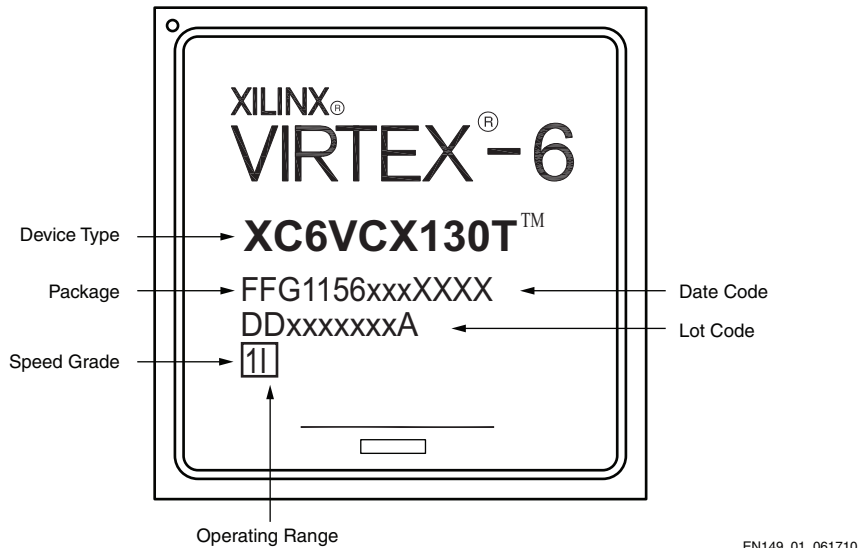
Figure 1: Example Device Top Mark

The XC6VCX130T is marked as shown in [Figure 1](#). The other devices listed in [Table 1](#) are marked similarly.
