# Virtex-4 XC4VLX100CES Errata

EN004 (v1.2) February 15, 2006

**Errata Notification**

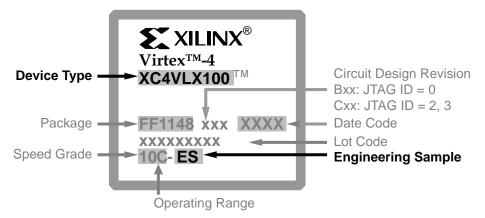
Figure 1: Example XC4VLX100CES Package Marking

The XC4VLX100 is marked as shown in Figure 1.
