Introduction

Thank you for participating in the Xilinx Virtex™-4 Engineering Sample Program. As part of this program, we are pleased to provide to you engineering samples of the Virtex-4 XC4VLX40 FPGA. Although Xilinx has made every effort to ensure the highest possible quality, these devices are subject to the limitations described in the following errata.

These errata apply to the XC4VLX40 devices as shown in [Table 1](#).

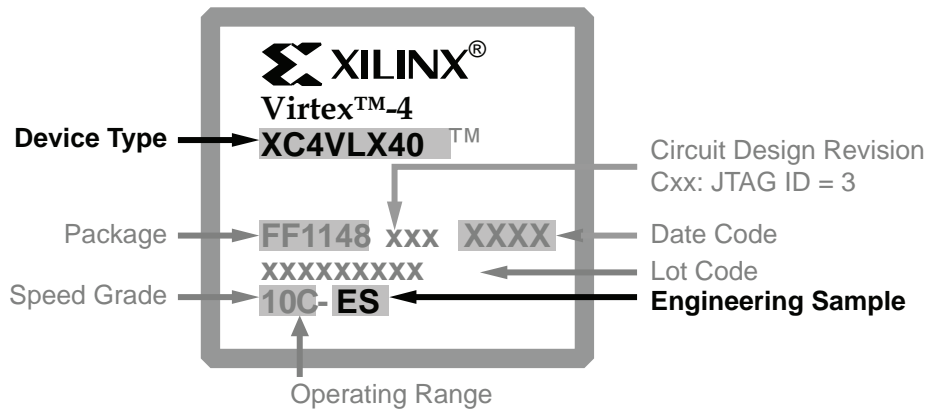
Figure 1: Example XC4VLX40CES Package Marking

The XC4VLX40 is marked as shown in Figure 1.
